Slope Stabilization Strategy

Bank Stabilization And Creek Works Enlargement Plan

Images Of Creek Stabilization and Restoration Work

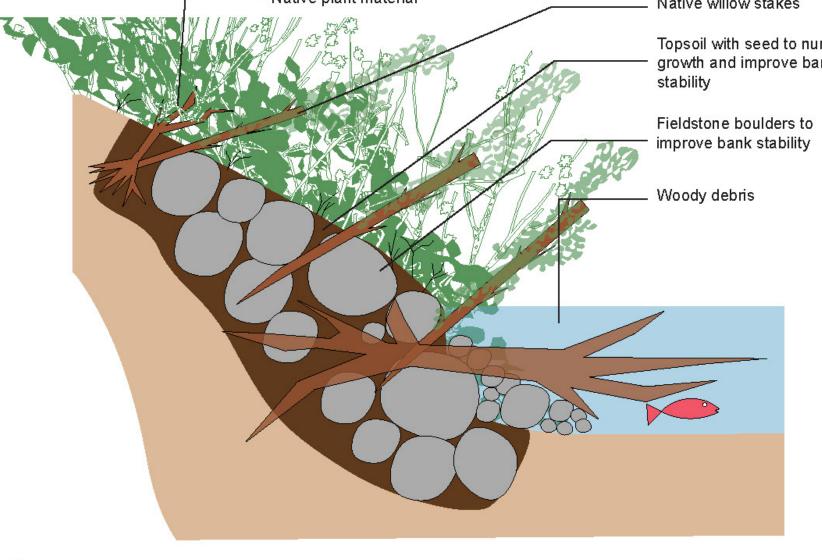
Vegetated Rock Revetment with Native Willow Stakes and Woody Debris

1+2 Example Of Vegetated Rock Revetment

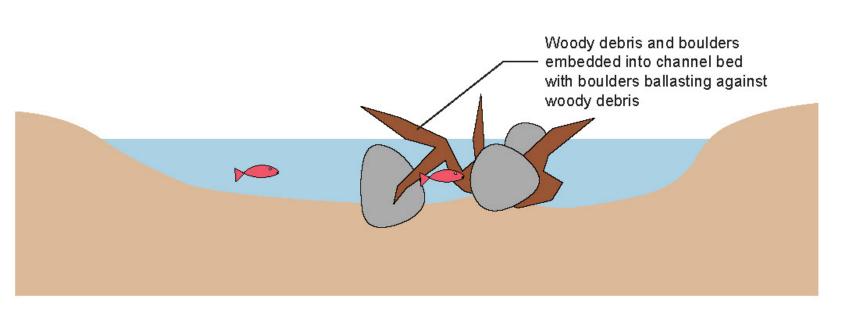
Boulder and Woody Debris Bed Feature for Fish Habitat

3 Fish Habitat Elements Boulder and Woody Debris Bed Feature

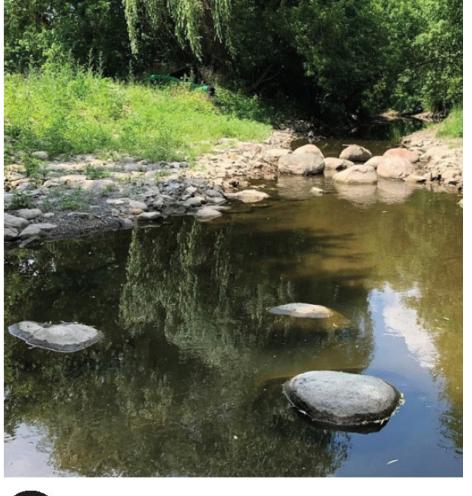
Fish Habitat Elements Boulder Weir Feature
